Manhole Inspection Summary

Manhole # S51K__023MH

Insp Date: **3/31/08 2:18 PM**

Location Address: **unknown alley**

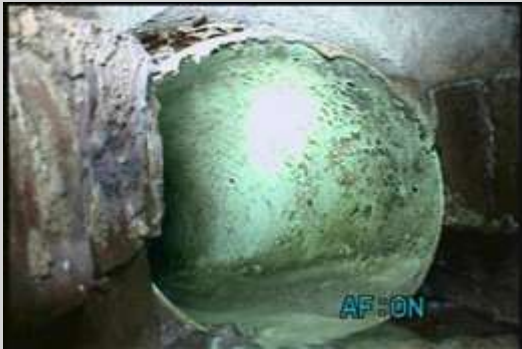
12 O'Clock Outflow

8 in. Circular Gravity Sewer
Pipe Out @ 12 O'Clock

Pipe Material: **PVC** ☐ Pipe Lined

Invert Depth: **8.46** (ft.) Flow Characteristics: **Fast**

Deposits: ☒ None ☐ Mud ☐ Sludge ☐ Debris ☐ Grease

Infiltration: **None** Pipe Seal Cond: **Unknown**

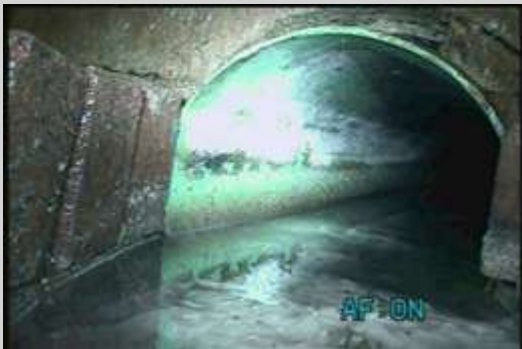
9 O'Clock Inflow

8 in. Circular Gravity Sewer
Pipe In @ 9 O'Clock

Pipe Material: **PVC** ☐ Pipe Lined

Infiltration: **None** Pipe Seal Cond: **Unknown**
